## 3. General Overview of Storm-Related Damage

This chapter presents a general overview of typical types of damage that resulted from Hurricane Katrina, as well as the effects caused by flood and wind damage. Section 3.1 characterizes flood damages observed by the MAT, with additional discussion and examples provided by different types of building occupancy (e.g., one- and two-family residential buildings, multi-family residential buildings, commercial buildings, critical and essential facilities, and historic buildings). Section 3.2 includes a similar treatment and breakdown for wind effects. More detailed discussions of the observations are presented in Chapters 4, 5, 6, and 7.

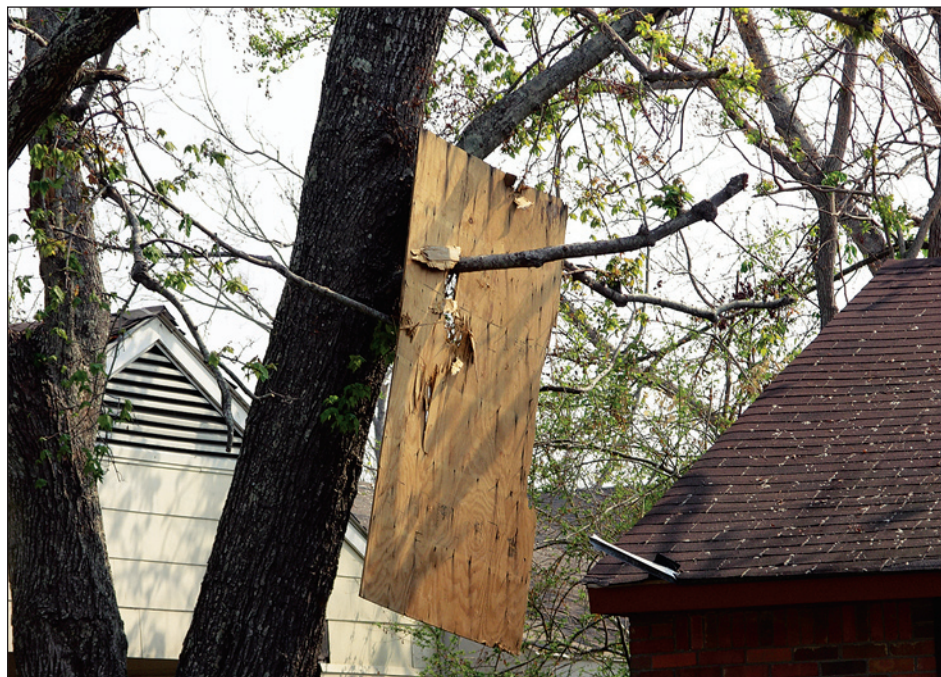
**Figure 3-31.**  
Roof sheathing was a  
source of windborne debris  
(Waveland, Mississippi).

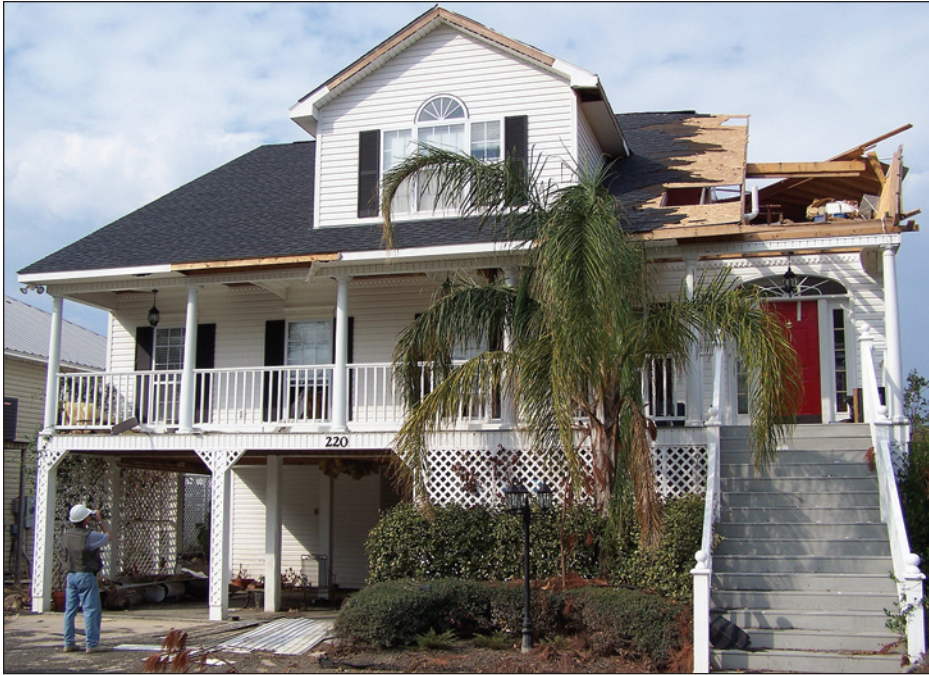
Figure 3-32.  
Relatively new home  
damaged from internal  
pressurization and lack  
of adequate connections  
(Pass Christian,  
Mississippi)

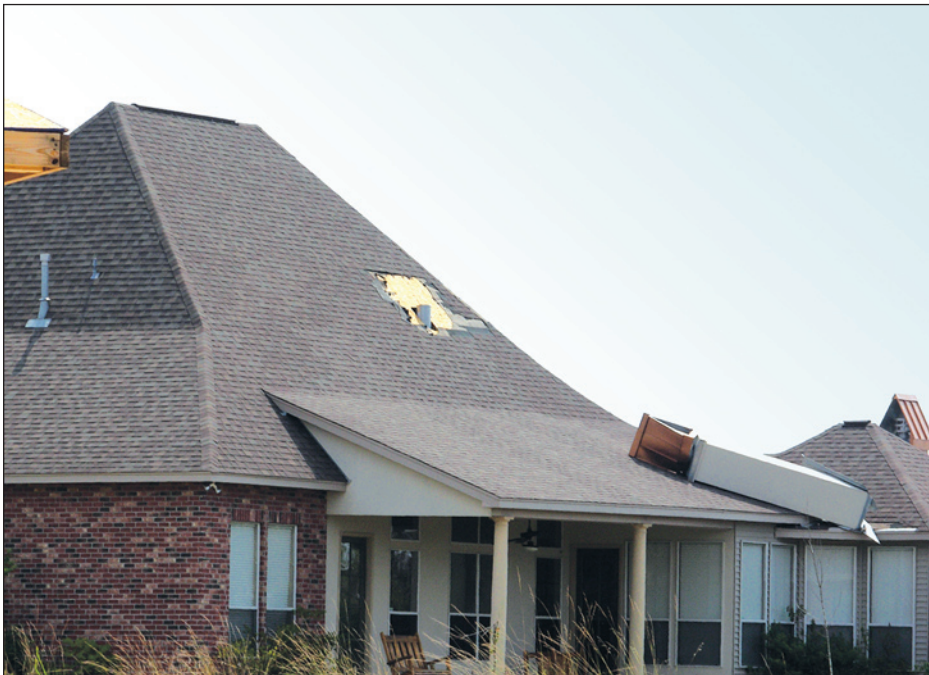
Figure 3-33.  
Loss of shingles  
and chimney failure  
caused by inadequate  
attachment (Slidell,  
Louisiana)

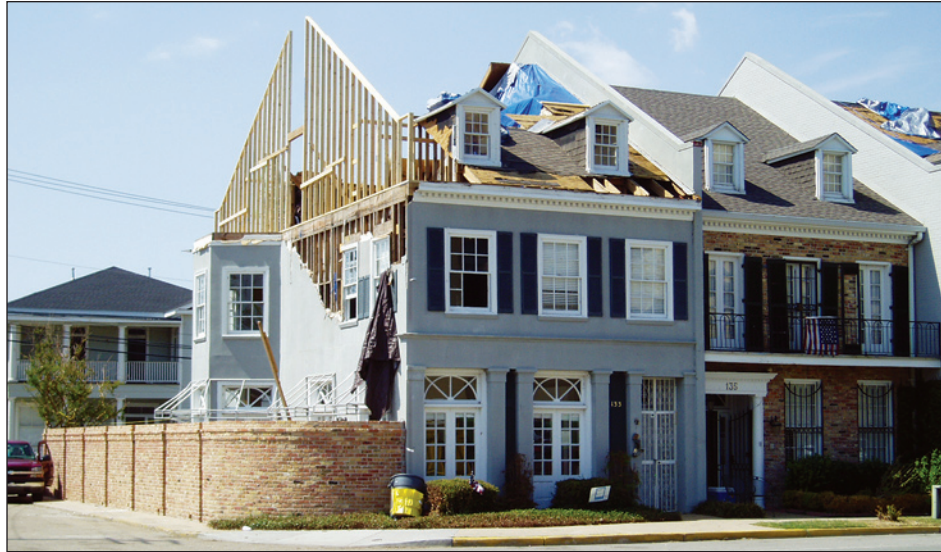
**Figure 3-34.**  
Row house with failed  
gable end wall and roof  
(gable end wall was  
being replaced when this  
photo was taken)  
(Biloxi, Mississippi).

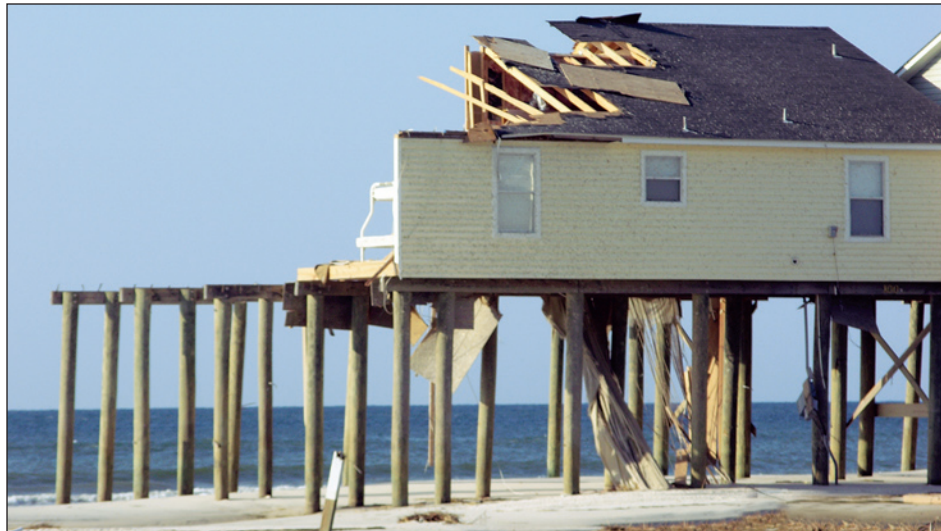
**Figure 3-35.**  
House constructed in  
2001 on Gulf side of  
Dauphin Island, Alabama,  
was destroyed by  
wind (Dauphin Island,  
Alabama)

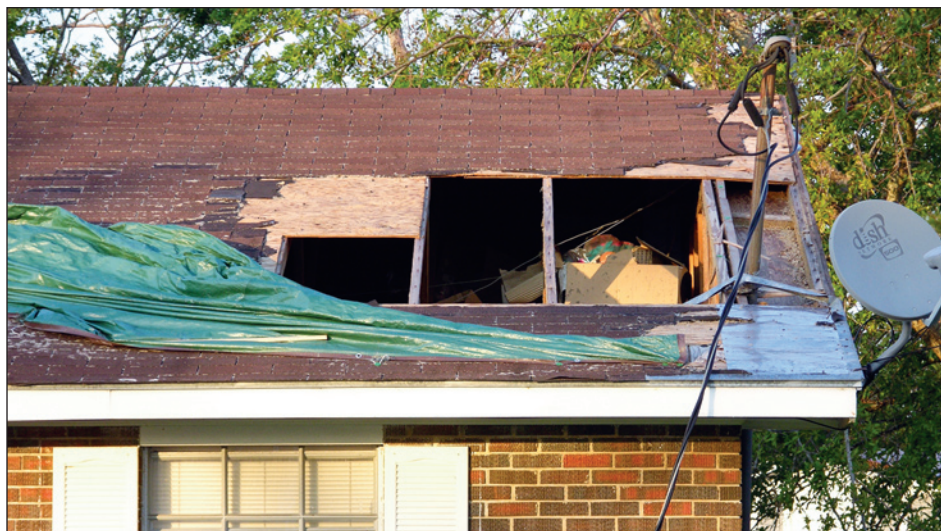
**Figure 3-36.**  
Roof sheathing damage  
to an older home  
(Gulfport, Mississippi)

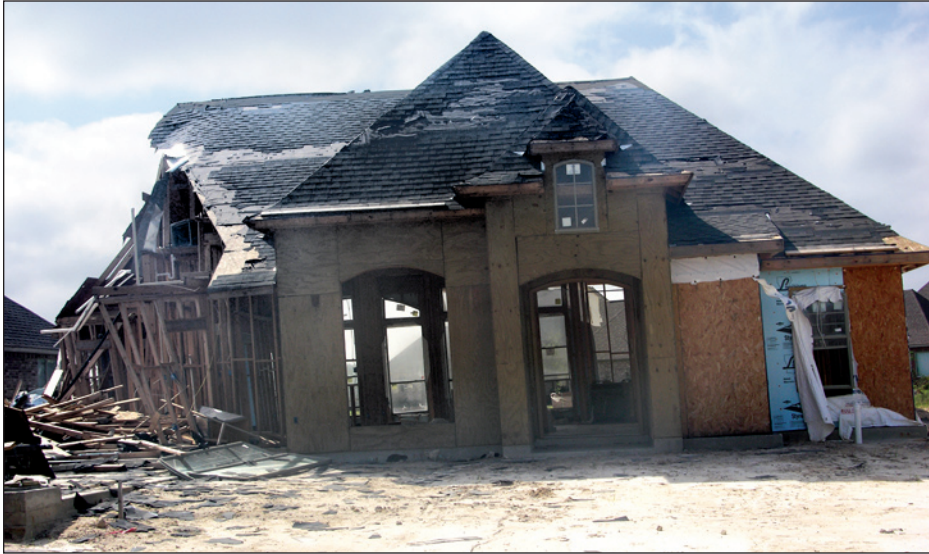
**Figure 3-37.**  
A home under construction racked severely when exposed to Katrina's winds. Its attached garage also collapsed (Slidell, Louisiana).

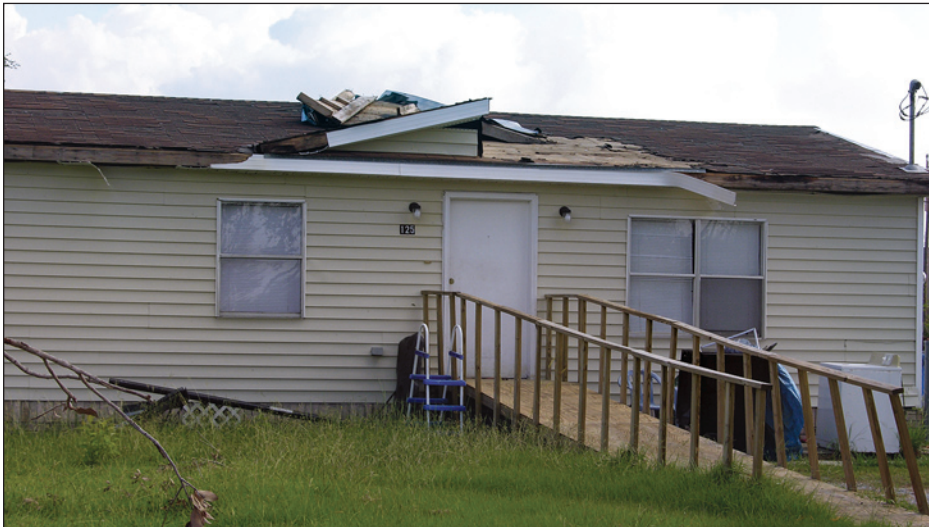
**Figure 3-38.**  
Manufactured home lost a gable roof over its entrance, asphalt shingles, and metal fascia along its eaves (Plaquemines Parish, Louisiana)

While most of the damage to manufactured housing was from flooding, wind damage was noted in both older and newer manufactured housing. Wind damage to manufactured homes included loss of asphalt shingle roofing, loss of vinyl siding, loss of large overhangs, and damage to window and door glazing (see Figure 3-38).

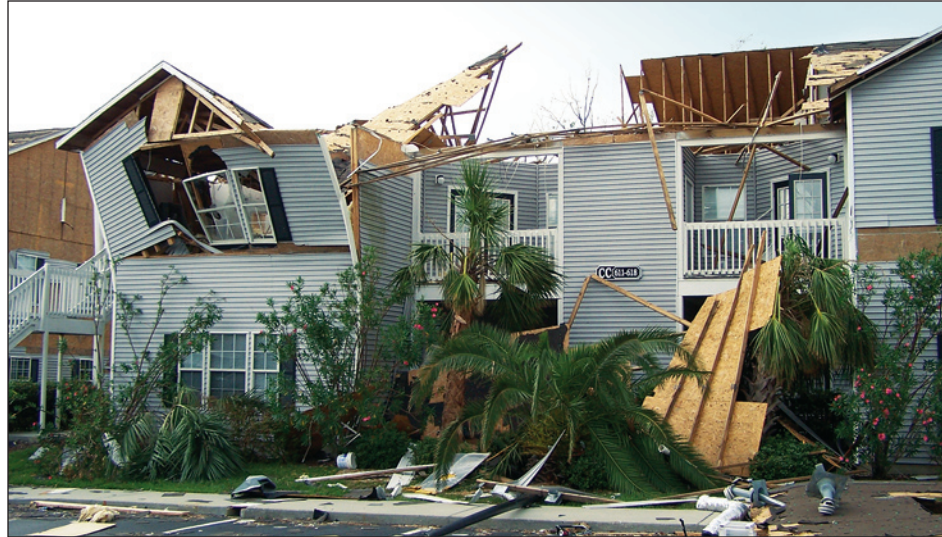
**Figure 3-39.**  
Apartment complex severely damaged by wind. Although wind speeds were less than current code-specified values, widespread and severe damage occurred at this development, a result of poor construction quality (Ocean Springs, Mississippi).

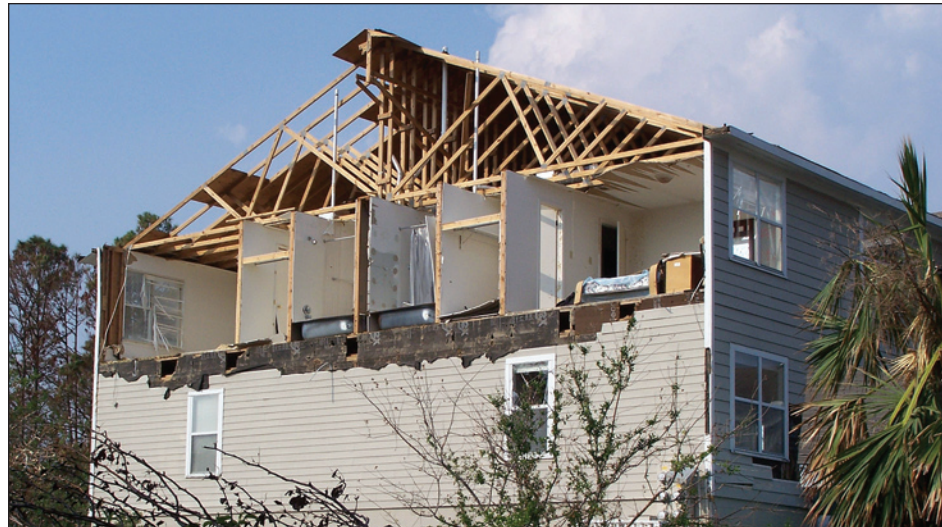
**Figure 3-40.**  
Multi-family, wood-framed residential building damaged by high winds (Waveland, Mississippi)

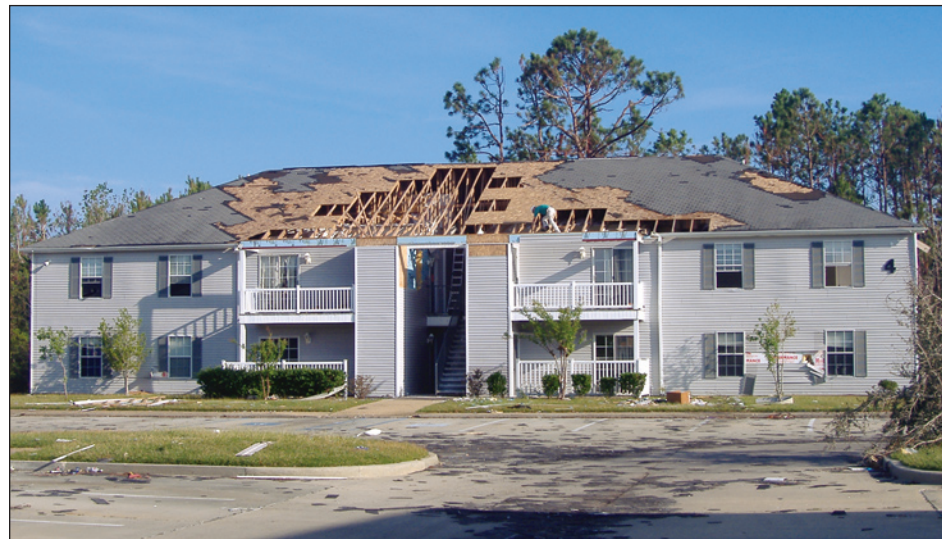
**Figure 3-41.**  
Wind damage to wood-framed, multi-family residential building (Long Beach, Mississippi)

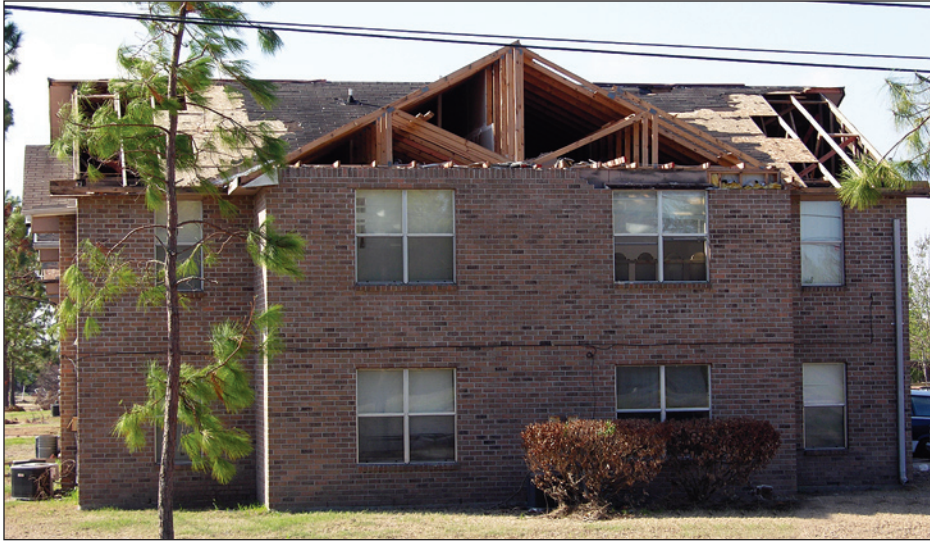
**Figure 3-42.**  
Gable end wall and roof sheathing loss to apartments near the City of Toca (St. Bernard Parish, Louisiana)

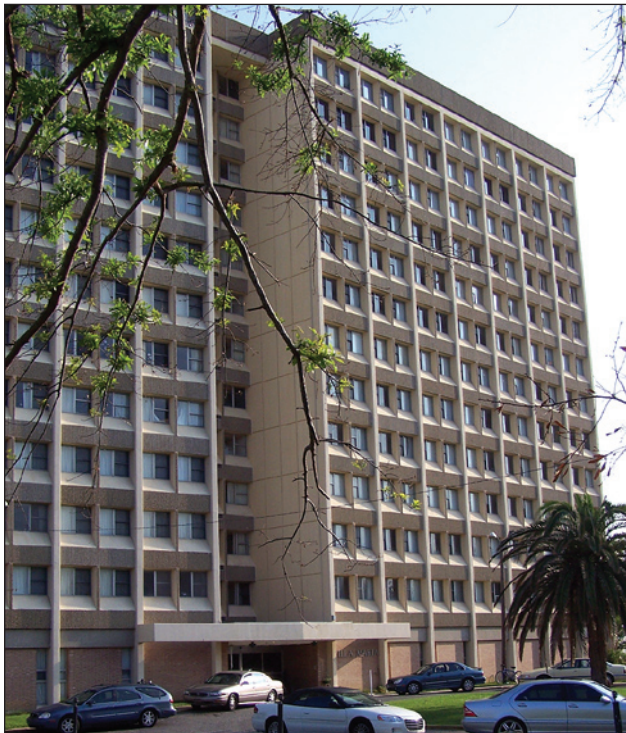
**Figure 3-43.**  
Multi-family residential building constructed with reinforced concrete frame showed no visible structural damage (Ocean Springs, Mississippi)

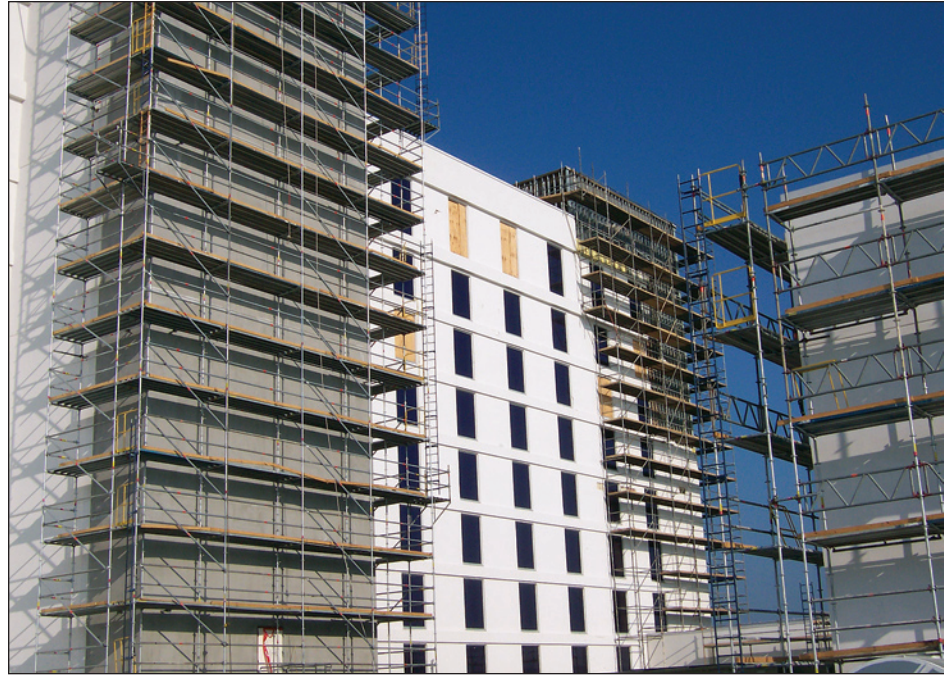
**Figure 3-44.**  
Reinforced concrete frame building that performed well structurally, but sustained extensive damage due to water intrusion from EIFS failure (Biloxi, Mississippi)

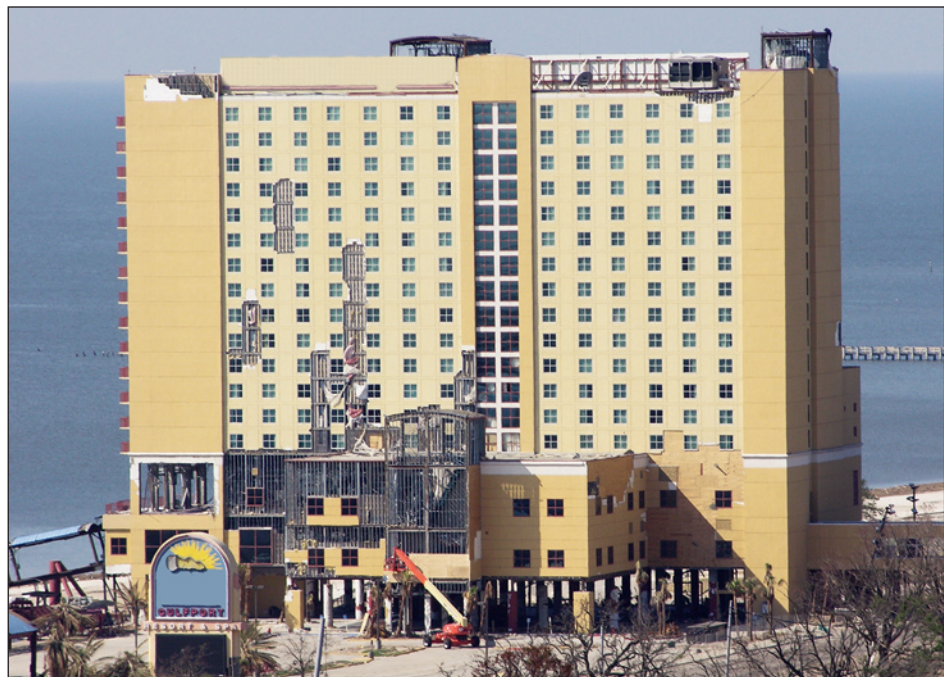
**Figure 3-45.**  
Damage to EIFS on hotel and casino (Biloxi, Mississippi)

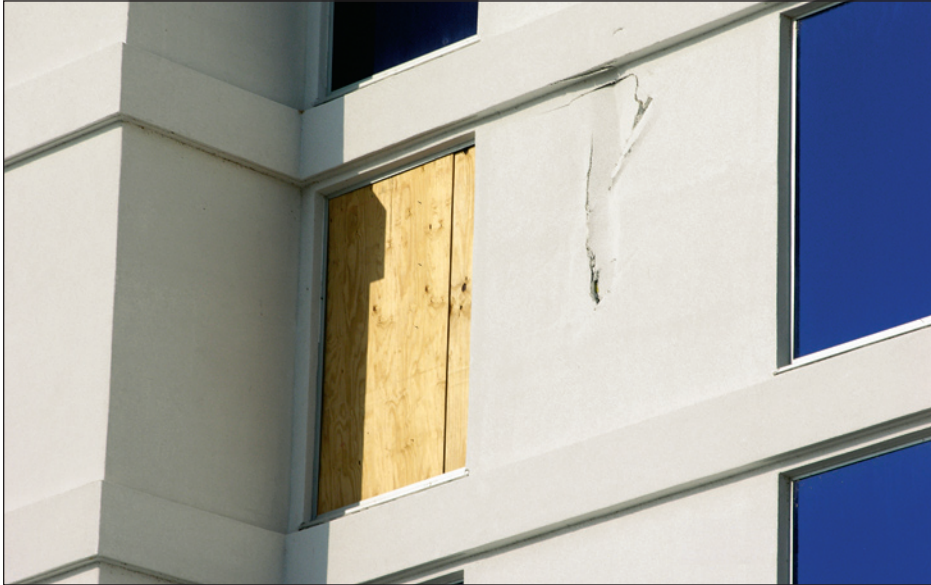
**Figure 3-46.**  
Closeup of high-rise building whose structure performed well, but experienced widespread damage to its EIFS envelope and some glazing damage (Biloxi, Mississippi)

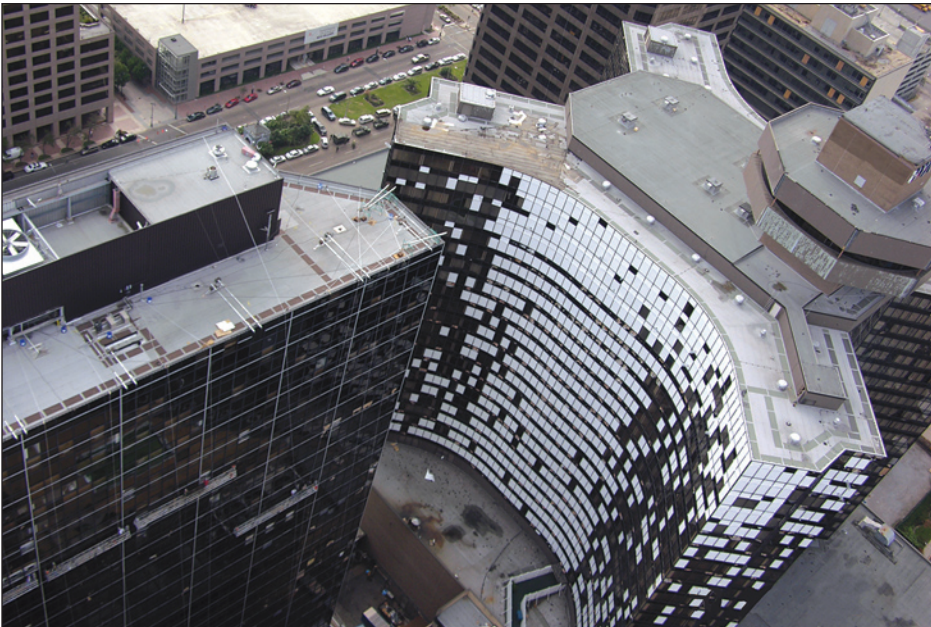
**Figure 3-47.**  
Roof aggregate was the primary windborne debris source for the glazing damage to the hotel and office building (New Orleans, Louisiana).

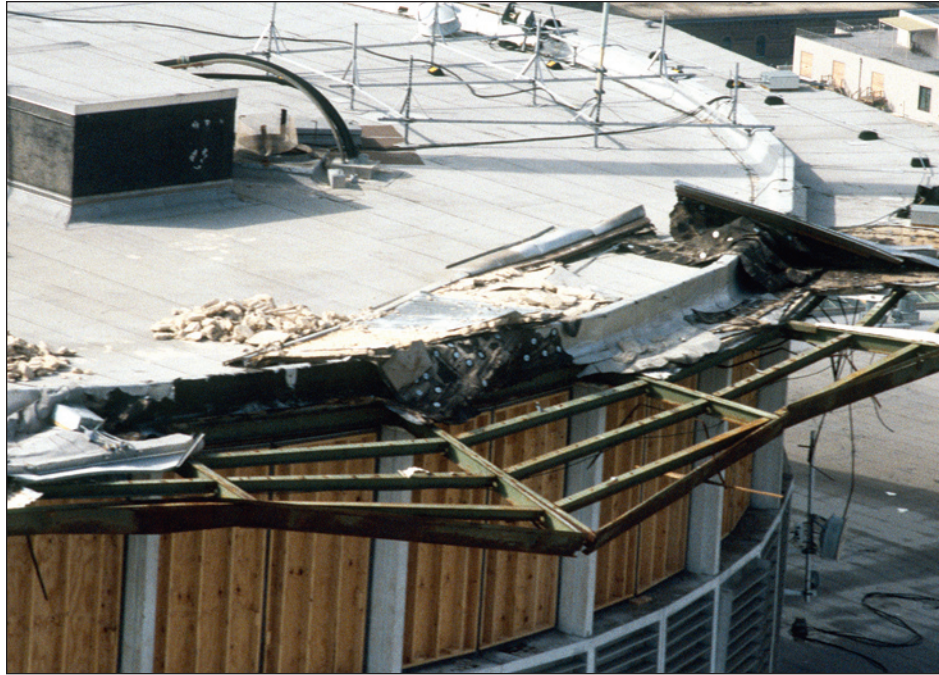
**Figure 3-48.**

The deck on this 400-foot tall building was lightweight insulating concrete over steel form deck. The form deck was blown from the deck supports (New Orleans, Louisiana).

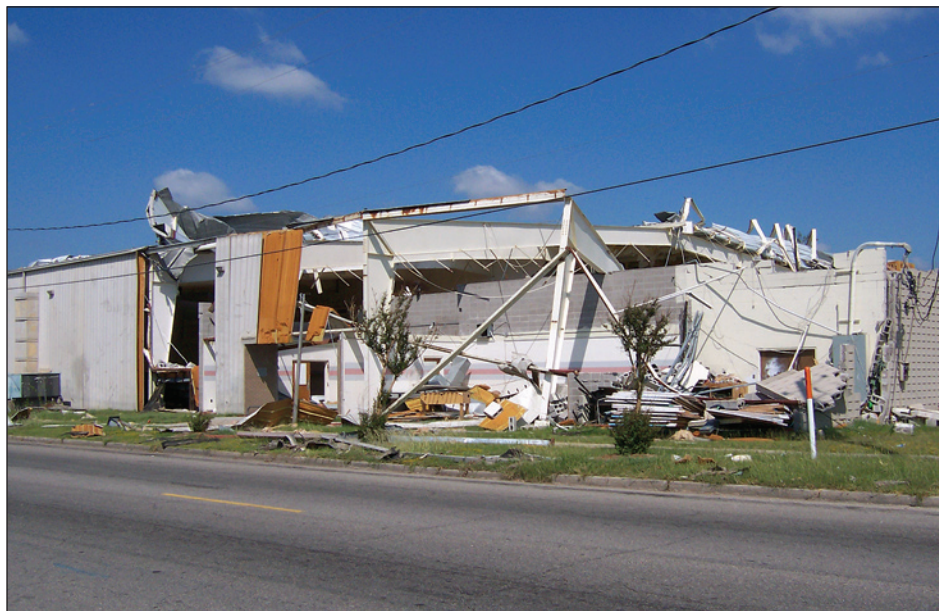
**Figure 3-49.**

Low-rise PEMB that was severely damaged by wind. The building was constructed with steel moment frames and purlins, metal roof and wall panels, and unreinforced masonry infill walls (Gulfport, Mississippi).

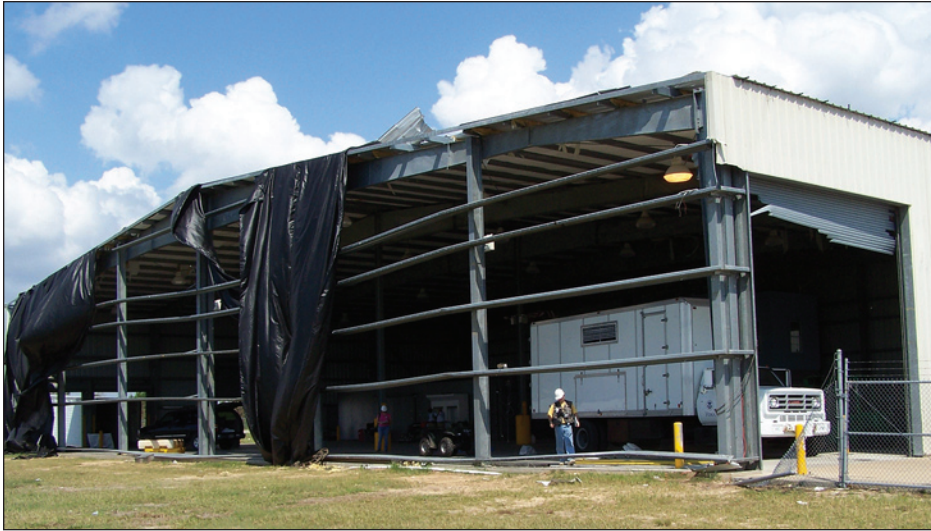
**Figure 3-50.**  
Low-rise PEMB at the Gulfport-Biloxi Airport severely damaged by winds. The building was constructed with steel moment frames and purlins, and metal roof and wall panels (Gulfport, Mississippi).

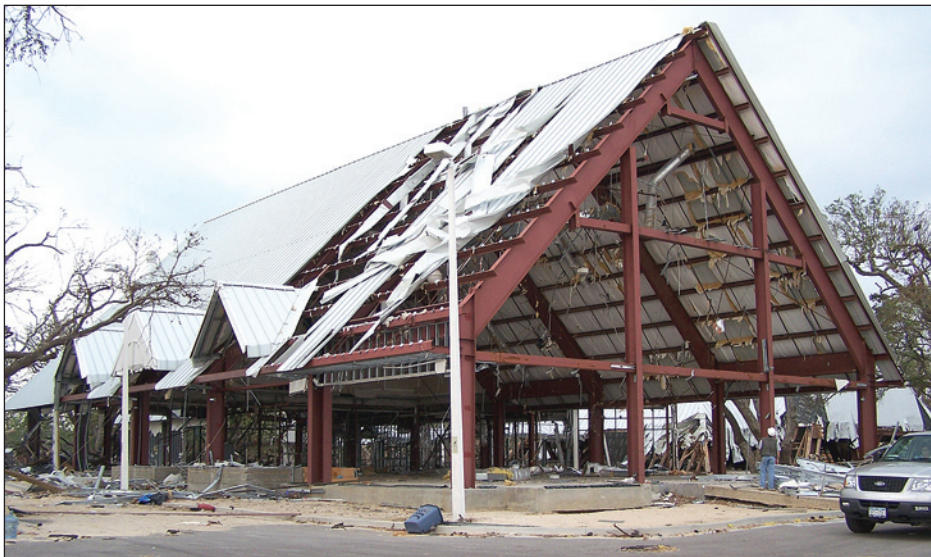
**Figure 3-51.**  
Wind, wave, and surge damage to St. Thomas Catholic Church. Destruction of the PEMB envelope likely reduced wind damage to the structure itself (Long Beach, Mississippi).

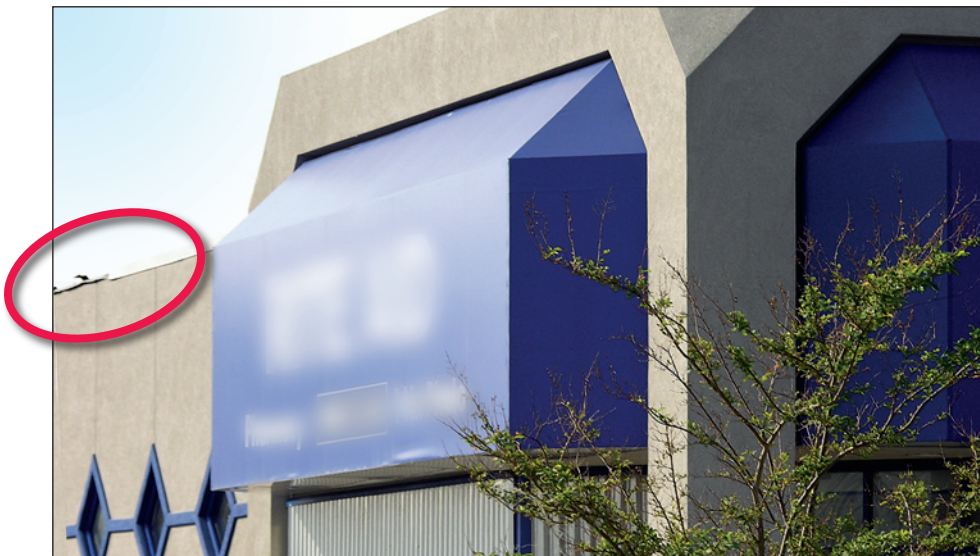
**Figure 3-52.**  
Newer low-rise PEMB that performed well structurally, but experienced some envelope damage. Metal coping along the top of the left wall (circle) was lifted by high winds (Bay St. Louis, Mississippi).

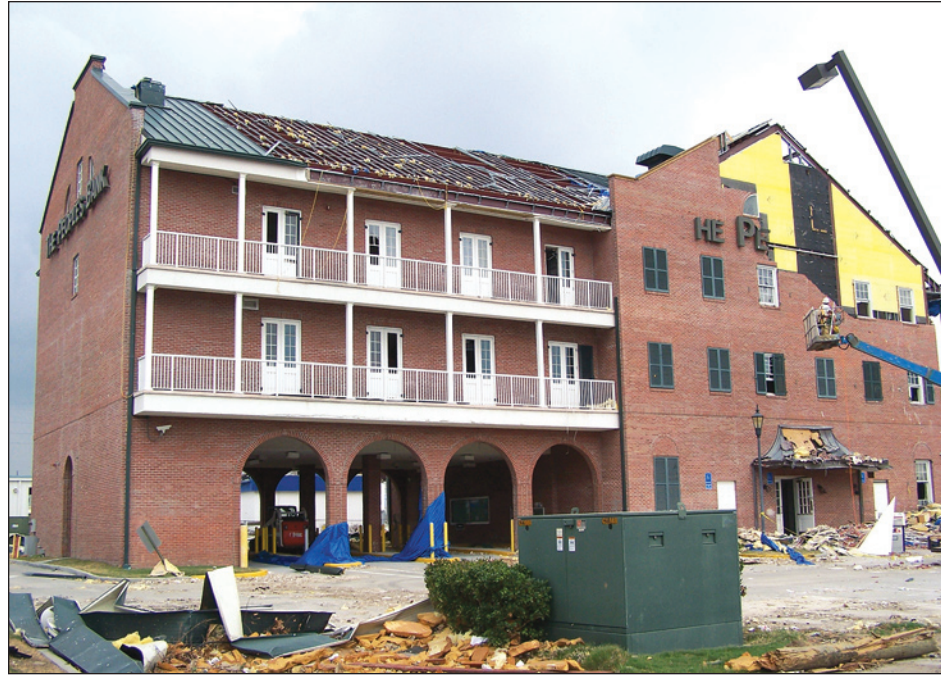
**Figure 3-53.**  
This bank building performed well structurally, but its envelope, specifically the metal roofing and brick, failed (Gulfport, Mississippi).

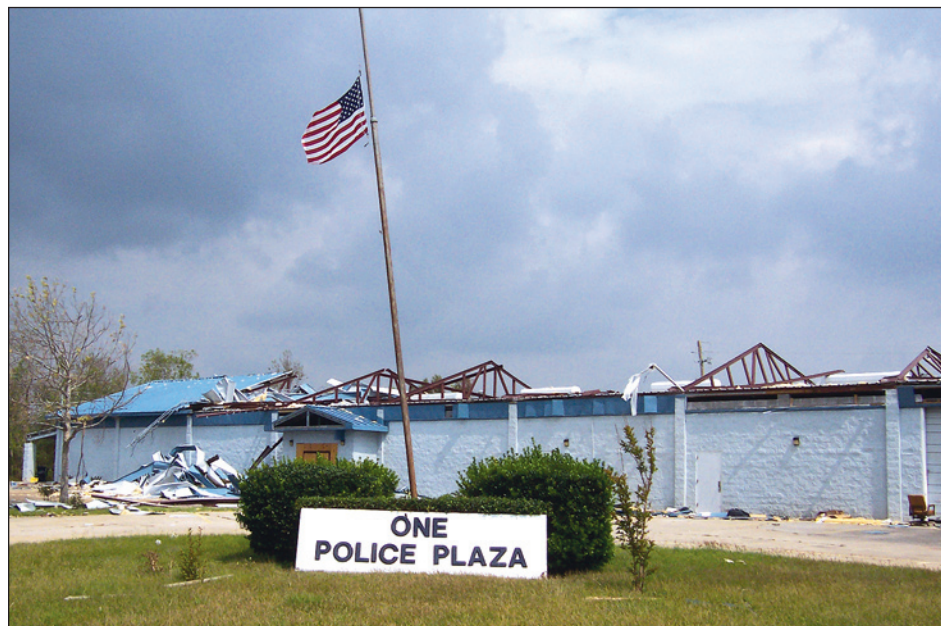
**Figure 3-54.**  
The Long Beach Police Station was severely damaged by high winds (Long Beach, Mississippi).

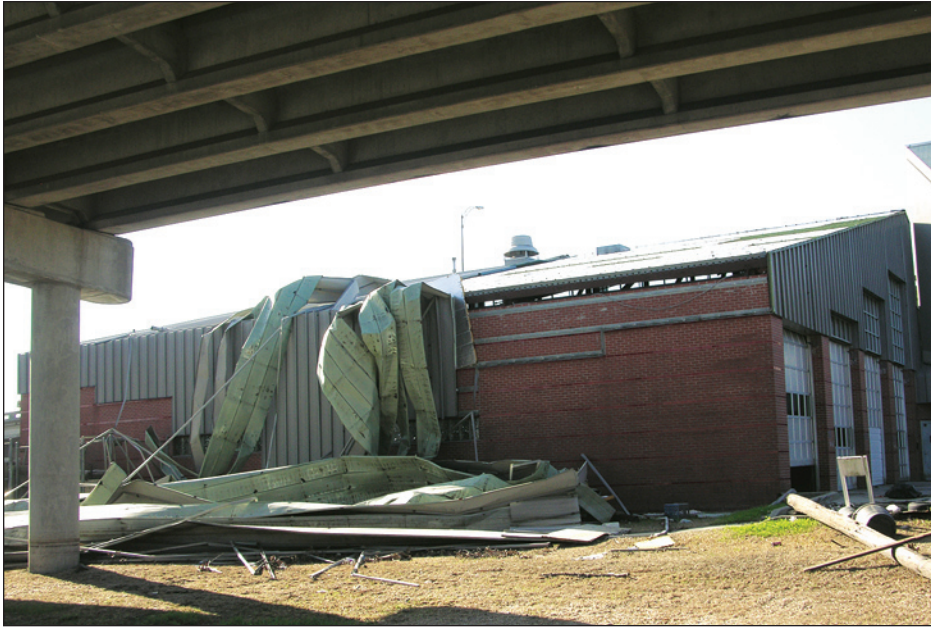
**Figure 3-55.**  
Wind damage to the New Orleans Fire Department 3rd District Headquarters (New Orleans, Louisiana)

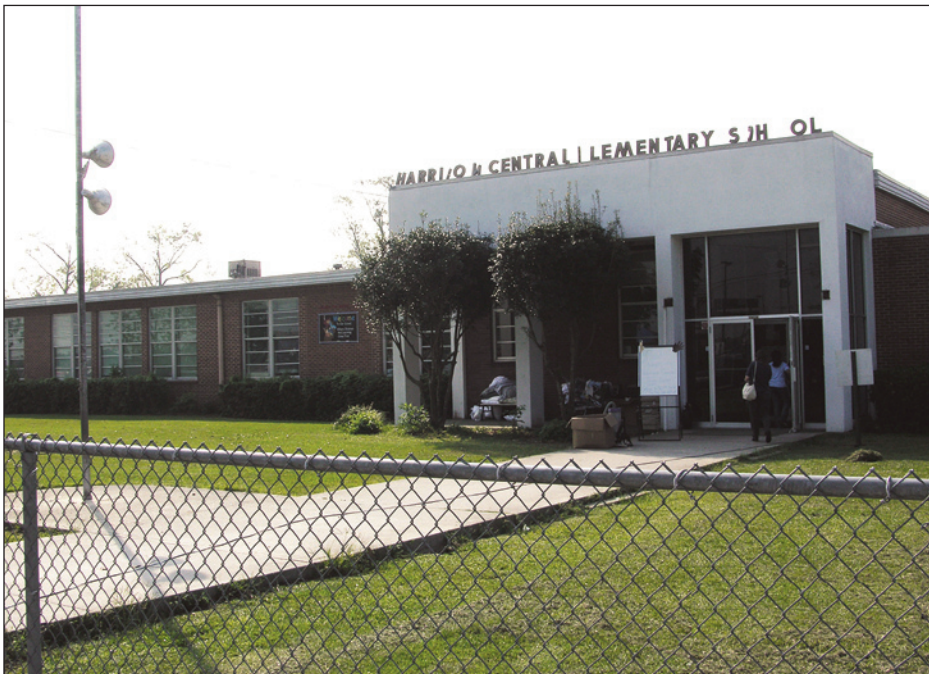
**Figure 3-56.**  
The Harrison Central Elementary School was used as an evacuation shelter during Katrina. Portions of its roof covering were blown off by high winds and many of its windows were broken by windborne aggregate from its own roof (Gulfport, Mississippi).

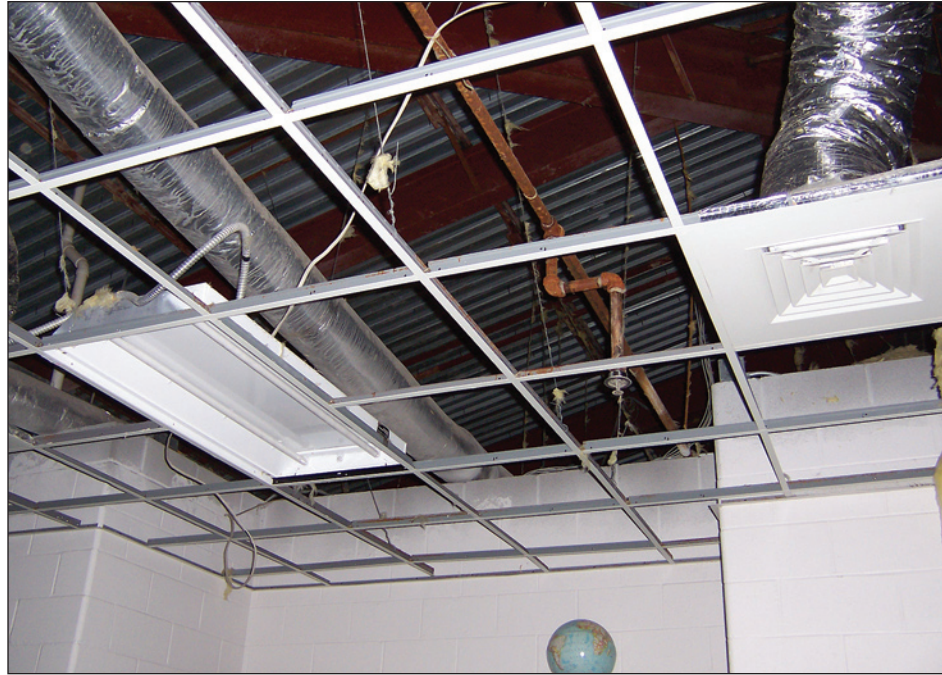
**Figure 3-57.**  
Ceiling damaged by wind and rain entry due to soffit failure (Gulfport, Mississippi)

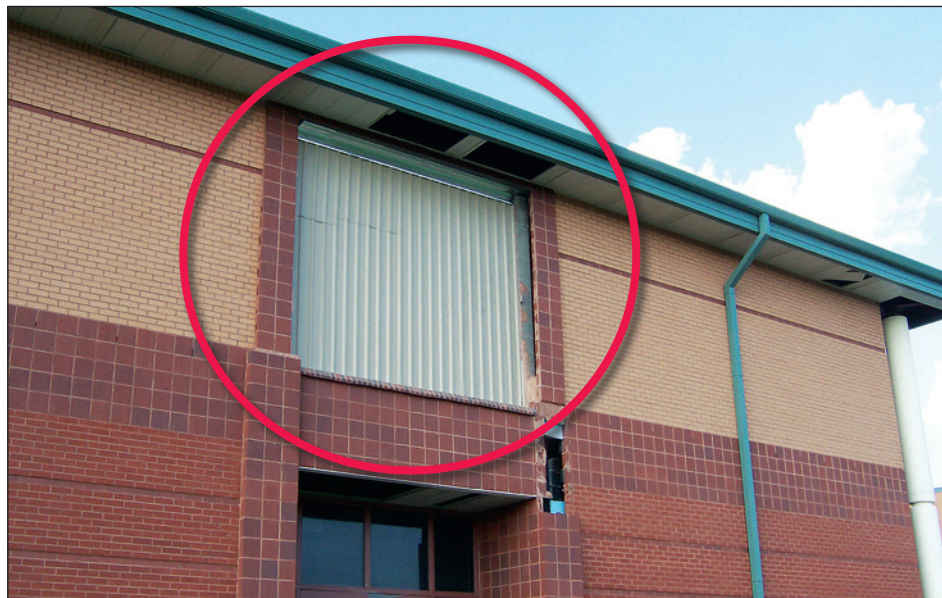
**Figure 3-58.**  
Window failed due to wind pressures, resulting in water entry into the building and damage to ceiling boards. After the failure, metal panels were installed for temporary protection (circled) (Gulfport, Mississippi).

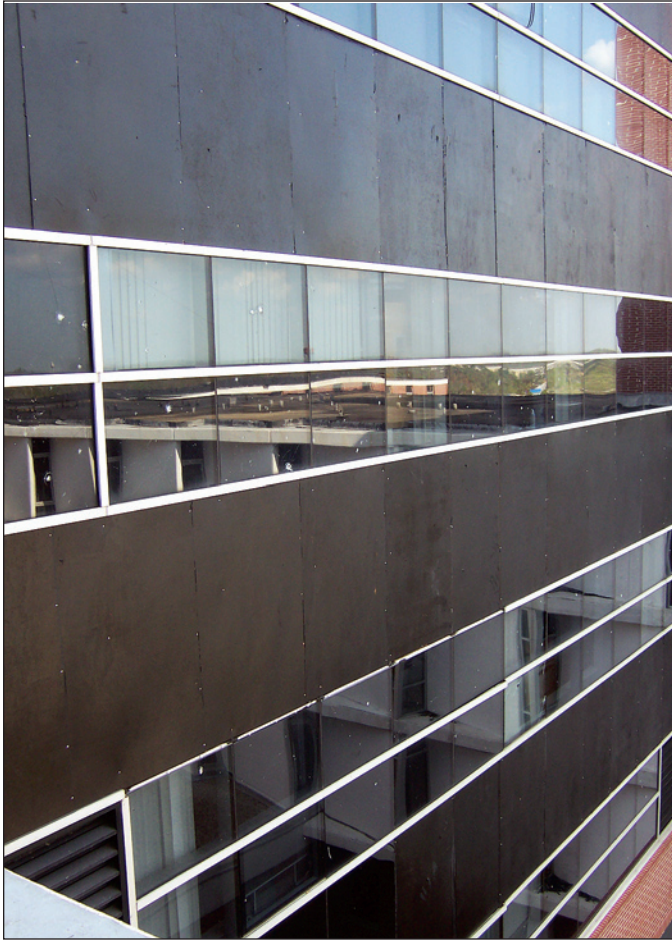
**Figure 3-59.**

Temporary repairs for broken windows in Memorial Hospital. The black panels are painted plywood installed after the spandrel panels were damaged by windborne roof aggregate from the hospital's own roofs (Gulfport, Mississippi).

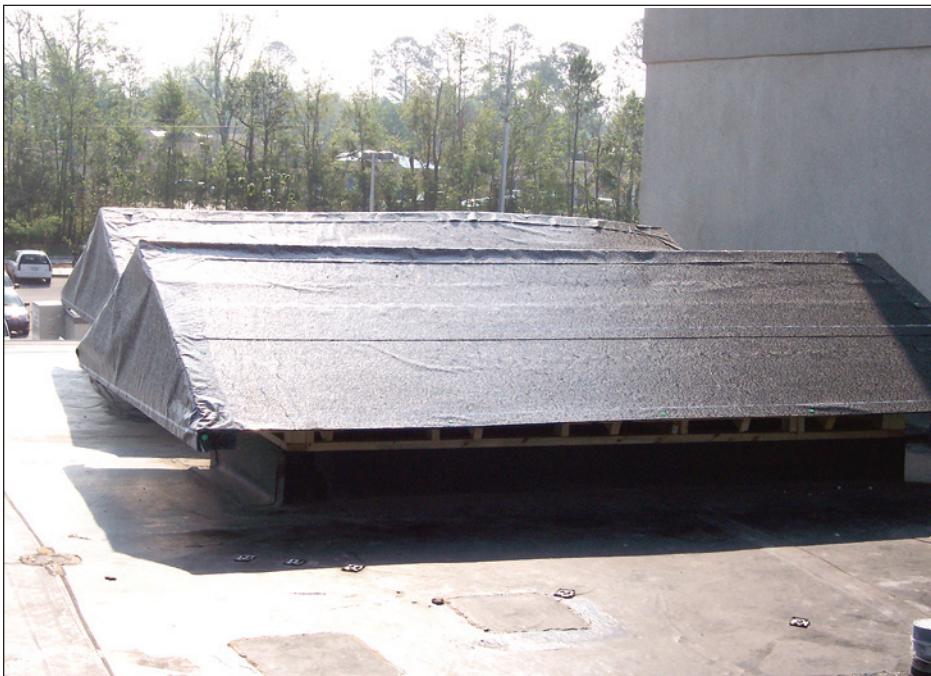
**Figure 3-60.**

Temporary repairs required after combustion air louvers for emergency generators were blown off of the roof at the Garden Park Medical Center (Gulfport, Mississippi)

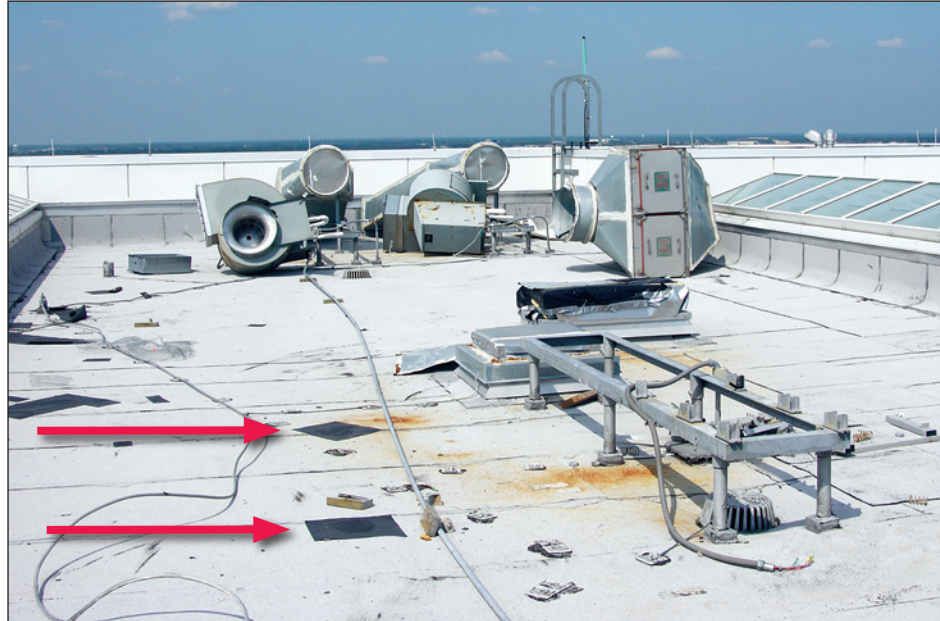
**Figure 3-61.**

The equipment on this new Federal courthouse blew away because it was resting on vibration isolators that provided lateral resistance, but no uplift resistance. Two large openings through the roof were left after the duct work blew away (temporary covers had been placed over the openings) (Gulfport, Mississippi).

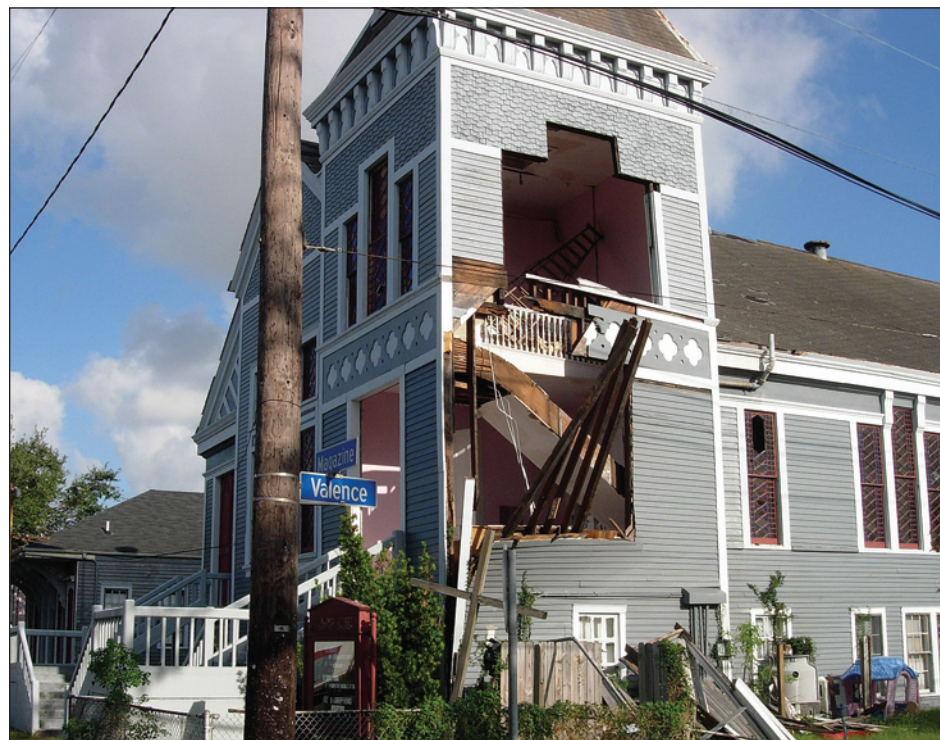
**Figure 3-62.**

Wind damage to a New Orleans church built in 1886 (New Orleans, Louisiana)

Wind effects on historic buildings were primarily limited to the removal of roof covering, sheathing, and limited curtain wall damage. Figure 3-62 is an example of a wood window that blew in. Even though these structures pre-date the building codes, buildings that had sufficient connection details in their design and construction, or were retrofitted, performed well against Hurricane Katrina's winds. More detail may be found in Chapter 6.
